# Manhole Inspection Summary

Manhole # S09UU\_009MH

Insp Date: **2/19/09 11:25 AM**

**Location** Address: **3501 FOREST PARK AVE**

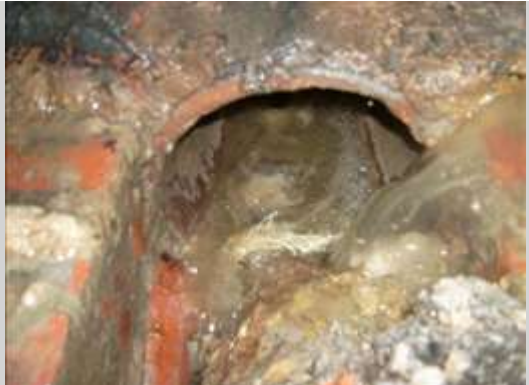
12 O'Clock Outflow

8 in. Circular Gravity Sewer  
Pipe Out @ 12 O'Clock

Infiltration: **None** Pipe Seal Cond: **Sound**
